Water Quality Assessment in a Rural Setting; A Case Study of Budaka District

Aloysius Nabucha¹, Albert I. Rugumayo²

Abstract. Pollution of improved water sources has been reported to be on the increase, especially in rural water sources, evidenced by the increasing outbreaks of waterborne diseases, despite the construction of many improved water sources. This raises doubt about the water quality in these sources. This paper presents the water quality, the factors that may impact water quality and the possible pollution mitigation interventions, in the case study of Budaka district, eastern Uganda.

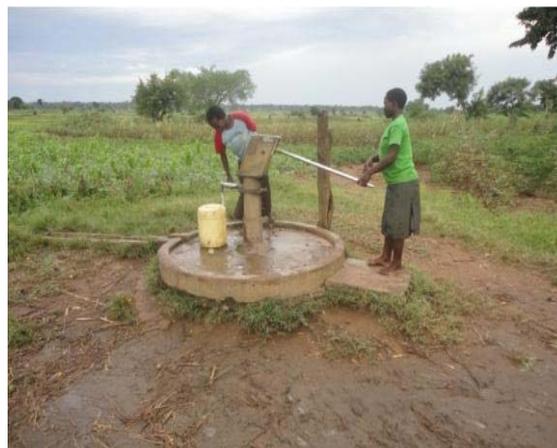
Figure 1: A poorly maintained shallow well with a cracked apron

The main pollution factors identified were; poor operation and maintenance of water sources particularly in terms of poor sanitation at the sources especially for shallow well and spring water sources, which indicated linkage of 67% and 70% respectively to *E.coli* pollution compared to boreholes which had

Shallow wells should be the least promoted for water supply in Budaka as the results indicated that they are heavily polluted by faecal coliform. The sources of pollution are sometimes unclear, which makes pollution control in shallow wells more complex and difficult to manage.

There should be effective and regular operation and maintenance of point water sources, particularly in terms of improved water source sanitation, which can significantly serve as an interventional mitigation measure, which could be achieved and enhanced through the adoption and promotion and use of an appropriate *Water Safety Plan*.
